表面蒸发式空冷器管束失效分析与防护研究

摘要: 目的 查明表面蒸发式空冷器管束失效原因, 提出避免再次失效的对策。方法 目测管束失效部位宏观形貌, 用金相显微镜得到管束基体的金相组织, 用电子显微镜观察管束失效部位的微观形貌, 用能谱获得管束基体及其失效部位的化学成分等。结果 目测可见失效部位管件表面有红褐色腐蚀产物存在, 且管壁减薄非常明显, 远离失效部位的管件表面完好; 金相显微分析表明, 管件基体金相组织与标准 20#钢金相组织吻合; 电子显微镜观察表明, 管壁表面腐蚀产物疏松多孔; 能谱分析表明, 管件基体化学成分主要缺少了 Cr、Ni、Cu 这 3 种合金元素, 管壁表面腐蚀产物化学成分由 Fe、Zn、O、S 组成。结论 Cr、Ni、Cu 合金元素的缺失导致了管基体耐蚀性能降低, 管程内烃类介质的含硫组分和管壳外换热介质的氧成分成为腐蚀源, 电偶效应下的全面腐蚀导致管件基体快速减薄而穿孔泄露。使用化学成分符合国标的 20#钢生产管束, 并保证管束表面镀锌层的完整性, 尽量减少烃类介质的含硫组分和换热介质的氧等含量, 可以避免管束再次失效。

Failure Analysis of the Tube Bundle on Air Cooler of Alkylation Equipment

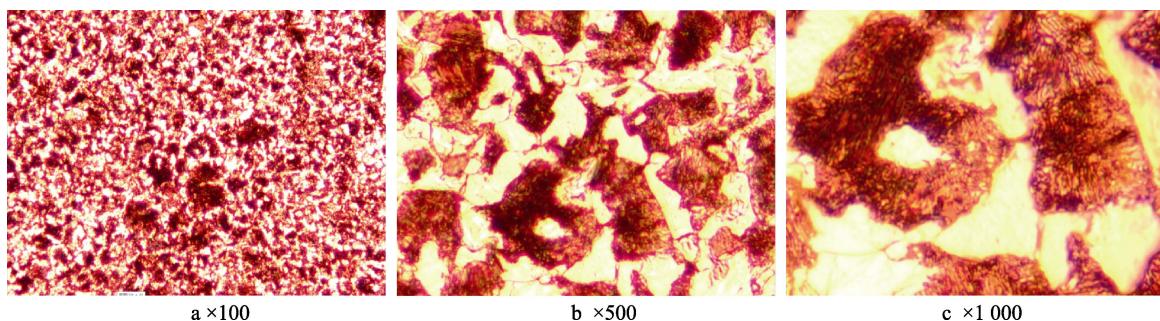
图2 基体(1#样品)金相组织
Fig. 2 Metallographic organization of tube matrix (1#sample)

1#样品的金相组织见图2, 可以看出, 其组织结构为铁素体加珠光体组织, 且珠光体组织无明显的分解痕迹, 与20#碳钢的标准金相组织相吻合^[28]。

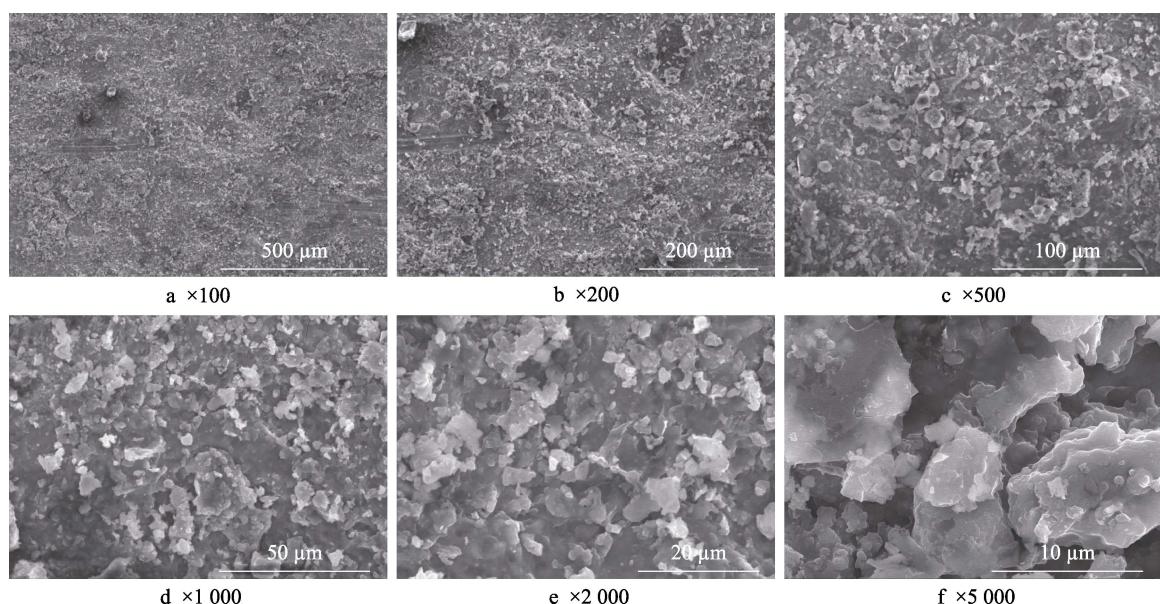
图3 管外壁表面的SEM形貌(2#样品)
Fig.3 SEM of outside surface of the tube (2#sample)

未除去腐蚀产物时2#试样外表面与内表面的SEM形貌分别见图3和图4。从图3可知, 低放大倍数下可见管外壁表面较为平整、无缺陷(图3a); 较高放大倍数下则明显可见腐蚀产物明暗相间地附着在管外表面(图3b-d); 更高放大倍数下(图3e-f)呈片状分布的腐蚀产物颗粒大小不一, 粒径平均3 μm左右, 最大10 μm左右, 且腐蚀产物呈现明暗相间的颜色, 说明其为混合物, 非单一物质所组成。从图4可知, 在低放大倍数下可见, 附着在管内壁表面的腐

由图 1、图 3—4 及表 2 可知, 20#钢管表面镀锌层比较致密与完整, 不是引起 20#钢管腐蚀的因素。同时, 从该石化公司提供的生产记录来看, 也不存在其他因素的破坏。例如, 人为的机械损伤、操作不当引起工艺介质剧烈波动等导致的 20#钢管束的损坏等。但是, 失效发生在管束与管板的连接处, 此处是应力集中和管束镀锌层极易破坏的地方, 对于整根管束来说, 镀锌层局部破损处裸露出的碳钢表面成为小阳极, 而镀锌层完好部位成为大阴极, 在小阳极与大阴极的电偶腐蚀效应与内应力的联合作用下, 20#钢加速腐蚀而减薄穿孔。空冷器管束仅仅服役 14 d 后就因腐蚀减薄, 导致其厚度仅剩下设计厚度的一半, 这也佐证了管束 20#钢发生腐蚀具备了不完善的制造因素。

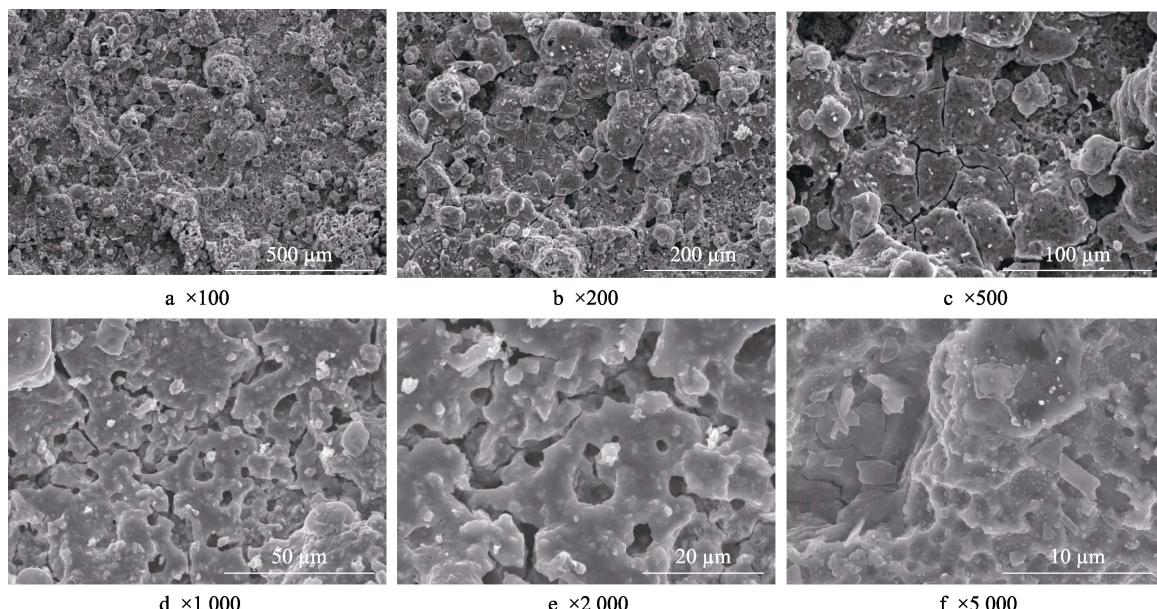
图4 管内壁表面的SEM形貌(2#样品)
Fig.4 SEM of internal surface of the tube (2#sample)

蚀产物疏松多孔(图4a);在较高放大倍数下腐蚀产物层呈多层排列,每层中的腐蚀产物颗粒呈片状分布(图4b—c);在高放大倍数下出现亮暗腐蚀产物颗粒,说明其成分不均匀且为混合物(图4d—f)。
