废气再循环单向阀阀片失效分析及腐蚀防护

(1. 内燃机可靠性国家重点实验室, 山东 潍坊 261061;
2. 潍柴动力股份有限公司, 山东 潍坊 261061)

Failure Analysis and Corrosion Protection of the Exhaust Gas Recirculation Valve

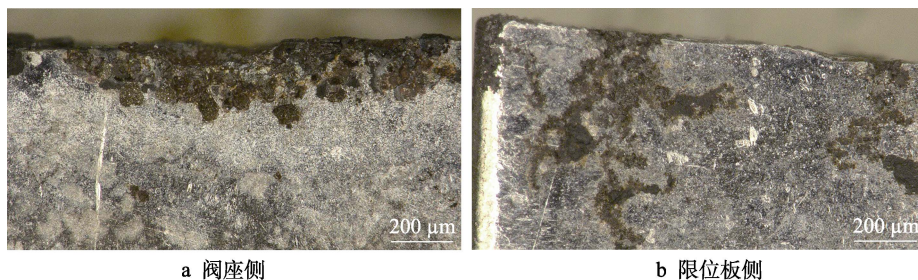
图 1 阀片表面的宏观形貌
Fig.1 Surface macromorphology of the valve: a) seat side; b) retainer side

将失效阀片在积碳清洗剂中超声清洗 10 min, 然后用纯水冲洗去除残留的积碳清洗剂, 最后将阀片放入无水乙醇、丙酮中超声清洗脱水、去除油脂, 冷风吹干后放入干燥器中备用。图 1 为体视显微镜下阀座侧及限位板侧阀片表面的宏观形貌。由宏观形貌可以发现阀片表面失去金属光泽, 且在断口附近存在密集分布的点蚀。

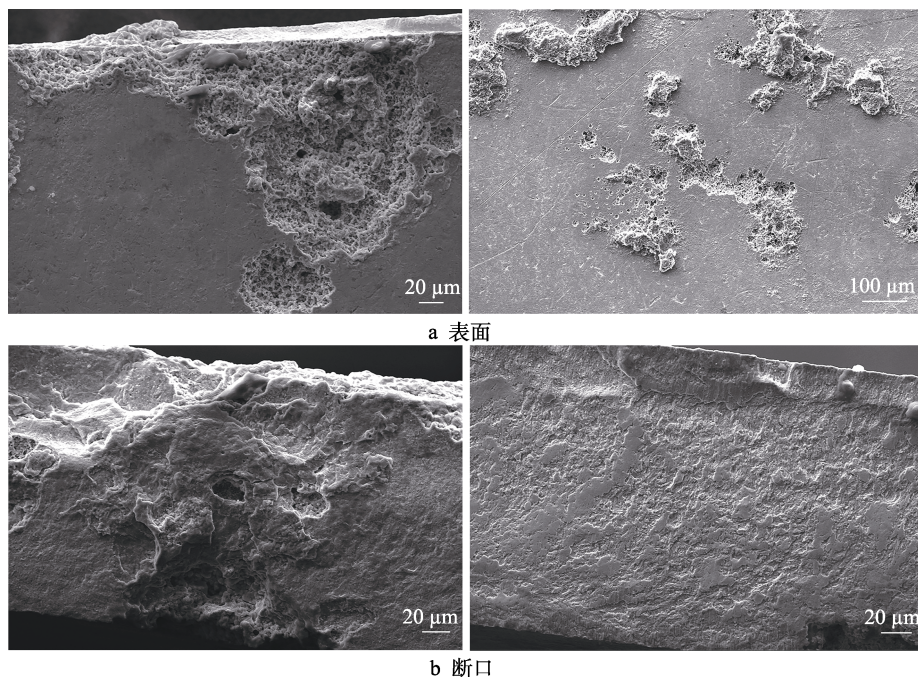
图 2 微观腐蚀形貌
Fig.2 Microscopy corrosion morphology: a) surface; b) fracture

图 2 为阀片的微观腐蚀形貌。阀片靠近断口表面有明显的点蚀现象, 在表面未去除完全的积碳下存在点蚀。在阀片断口上存在点蚀, 断口整体较平整表现为脆性断裂特征。图 3 为利用 EDS 得到的阀片表面

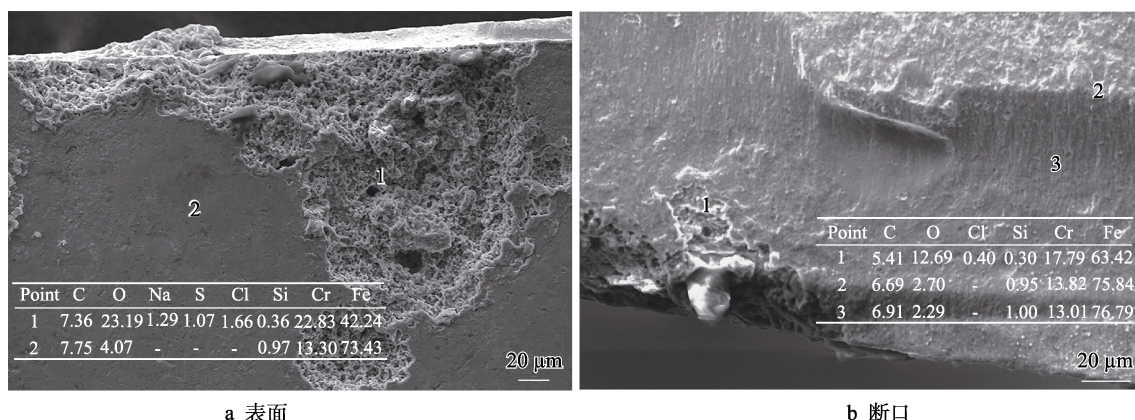
图 3 阀片元素分布
Fig.3 Elemental composition of the valve: a) surface; b) fracture

及断口的元素分布。由元素分布可以看出, 腐蚀产物主要是铁和铬的氧化物, 在蚀孔内有氯元素的出现, 且相对于腐蚀轻微区域, 蚀孔内铬元素的含量高。综合阀片表面及断口的宏观、微观形貌可以得出阀片失效的主要原因是腐蚀降低了其承载能力, 在应力作用下发生断裂。

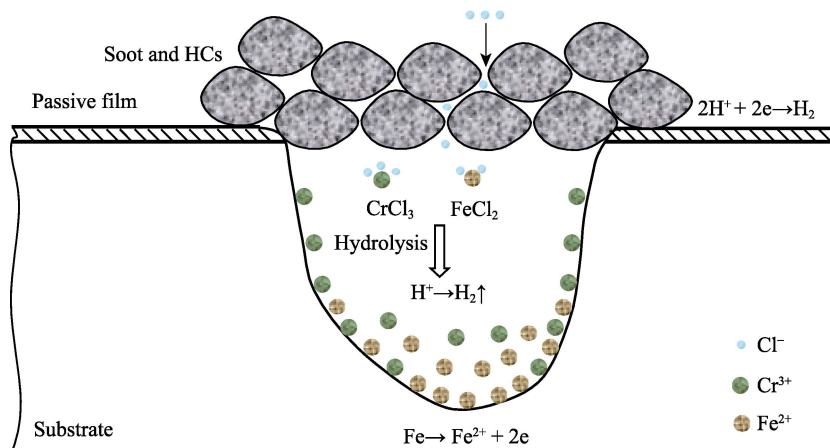
图 4 积碳下点蚀生长示意图
Fig.4 Schematics of the evolution of the pitting under carbon deposition

钝化膜中的氧原子竞争吸附,破坏钝化膜,形成早期点蚀^[17]。如图4所示,积碳沉积在阀片表面,积碳下的 Fe^{2+} 难以扩散迁移离开材料表面,引起局部正电荷过剩,为了维持体系的电中性,促使缝外的 Cl^- 经由积碳颗粒间隙迁入缝内来保持电荷平衡。 Cl^- 与 Fe^{2+} 、 Cr^{3+} 发生的氯化合反应,形成氯化物 FeCl_2 与 CrCl_3 ,氯化物发生式(3)与式(4)所示的水解反应^[18]。

水解后产生的 H^+ , 使得缝内介质酸化, 电极反应的阴极过程加强, 与其共轭的阳极溶解反应加速, 产生更多的 Fe^{2+} 、 Cr^{3+} , 吸引基体中的 Fe 原子、 Cr 原子向蚀孔扩散参与电化学反应, Fe^{2+} 全部发生扩散和水解, 而部分 Cr^{3+} 会在蚀坑内壁上重新沉积形成铬的氧化物保护层, 这从 EDS 的元素分布结果中可以看出, 与腐蚀轻微的区域相比, 发生明显腐蚀区域的 Cr 元素含量更高而 Fe 元素含量更低。随着反应的进行, 蚀孔内外形成腐蚀原电池, 在点蚀坑底部发生自催化过程的阳极反应, 点蚀向材料的纵深方向发展^[19]。因此可以从减少积碳在阀片表面的沉积和提高阀片的耐蚀性两方面延长 EGR 单向阀阀片的腐蚀寿命。

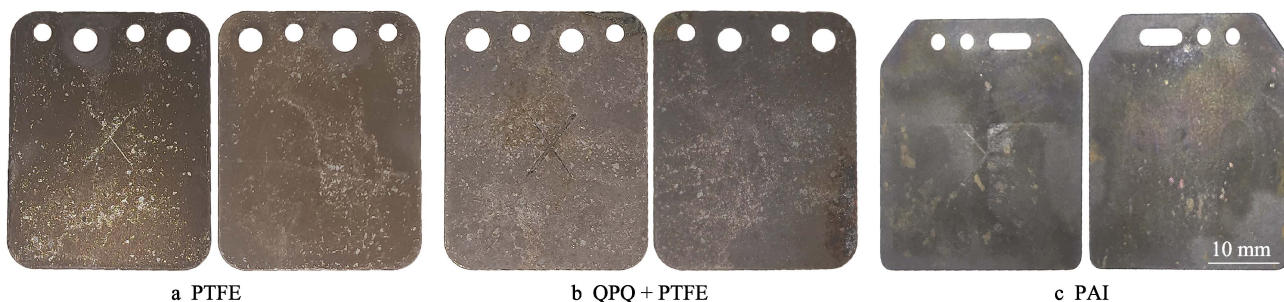
图 11 3 种涂层阀片浸泡 720 h 后的宏观形貌

图 11 和图 12 分别为 3 种涂层阀片在模拟冷凝水中浸泡 720 h 后的表面宏观形貌和截面形貌。浸泡试验结果显示,PTFE 试样浸泡 120 h 后出现涂层剥落,432 h 后出现腐蚀;QPQ+PTFE 试样浸泡 120 h 后出现涂层剥落,144 h 后出现腐蚀;PAI 涂层浸泡 336 h 后出现涂层剥落,480 h 后出现腐蚀。3 种涂层和基体间均有明显界限,说明两者的结合力均不好,3 种涂层的涂层厚度均减小,PTFE 涂层/金属界面有孔洞和裂纹等缺陷,基体表面平整;QPQ+PTFE 的涂层裂纹和孔洞明显,涂层丧失了保护性,基体表面可观察到明显的腐蚀现象;PAI 涂层未发现明显的裂纹和孔洞缺陷,涂层防护性能高,但涂层整体减薄程度较前两者大。3 种涂层均在较短时间内出现了不同程度的脱落,可能的原因是涂层厚度小,孔隙率等缺陷较多,涂层的耐渗水性能低。由 720 h 后的宏观形貌可以发现,PAI 涂层的耐蚀性最好,涂层剥落少,其次是 PTFE 涂层,而 QPQ+PTFE 涂层的耐蚀性最差,涂层大面积脱落且划痕处和阀片边缘出现了明显的腐蚀产物,白亮层沉淀析出铬的氮化物,引起基体贫铬,耐蚀性降低^[27]。

3) PAI 涂层和 PTFE 涂层可以作为防护涂层, 能在一定程度上提高单向阀的服役寿命。
