# 热浸镀 Zn-11Al-3Mg 镀层黑点缺陷形成机理研究

**摘要:** 目的 研究 Zn-11Al-3Mg 镀层黑点缺陷位置与正常位置组织特征差异, 阐明黑点缺陷的形成机理, 寻找导致黑点缺陷的原因, 从而控制和消除黑点缺陷。方法 以工业生产的 Zn-11Al-3Mg 镀层钢板表面的黑点缺陷为研究对象, 综合运用光学显微镜(OM)、扫描电镜(SEM)、能谱仪(EDS)、双束聚焦离子束显微镜(FIB-SEM)等, 详细对比了缺陷位置和正常位置镀层显微组织的差异, 分析了引起镀层组织差异的根本原因, 揭示了 Zn-11Al-3Mg 镀层表面黑点缺陷的形成机理。结果 Zn-11Al-3Mg 镀层组织由初生 Al 枝晶和枝晶间第二相组成, 缺陷位置和正常位置枝晶间第二相显微组织存在明显差异, 宏观上表现为局部黑点缺陷。缺陷位置枝晶间第二相的平均成分与原始镀液成分接近, 组织为细小的颗粒状 Zn/Al/MgZn<sub>2</sub> 三元组织, 未出现明显的 Zn/MgZn<sub>2</sub> 二元共晶; 而正常位置枝晶间第二相由大量的层片状 Zn/MgZn<sub>2</sub> 二元共晶及少量 Zn/Al/MgZn<sub>2</sub> 三元共晶组成。造成上述镀层组织差异的根本原因是镀后凝固过程中冷却速率不均匀。结论 在镀后冷却速率局部过高的位置, 在初生 Al 枝晶析出后, 剩余液相被快速冷却至三元共晶反应温度以下, 促使熔融态的镀层快速凝固, 从而形成了与镀液成分相近、组织细小的枝晶间第二相。而在镀后冷却速率较低的区域, 依次发生了初生 Al 枝晶析出、二元共晶反应、三元共晶反应, 形成了不同的镀层组织。

## Formation Mechanism of Dark Spot Defects on Hot-dip Galvanized Zn-11Al-3Mg Coating

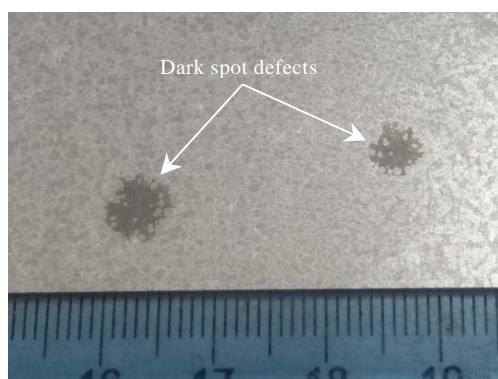
Zn-11Al-3Mg 镀层钢板表面的黑点缺陷外观如图 1 所示,外观接近圆形,但边缘并不整齐,颜色比周围镀层暗,故宏观表现为“黑点”缺陷。黑点尺寸大小不一,直径为 3~10 mm。生产 Zn-11Al-3Mg 镀层钢板的镀液成分(均为质量分数)为 11%Al、3%Mg、0.2%Si,余量为 Zn。镀层重量为 275 g/m<sup>2</sup>(双面)。镀层表面有/无铬钝化后处理。基板为普通的低碳铝镇静钢,厚度为 1.4 mm。

图 1 Zn-11Al-3Mg 镀层表面黑点缺陷宏观照片  
Fig.1 Macro appearance of the dark spot defects on Zn-11Al-3Mg coating

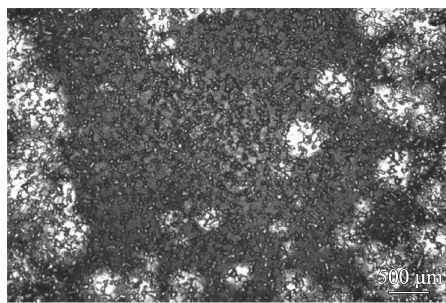
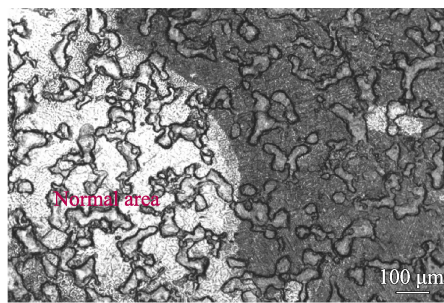
黑点缺陷内部及缺陷边缘与正常镀层交界位置的光学显微镜表面形貌照片如图 2 所示。在光学显微镜下,黑点缺陷位置与正常位置的颜色存在明显差异,黑点缺陷位置颜色较深,而正常位置颜色较浅。在黑点缺陷的边缘,存在一些圆形区域,颜色也较浅。

图 2 黑点缺陷表面光学显微镜形貌

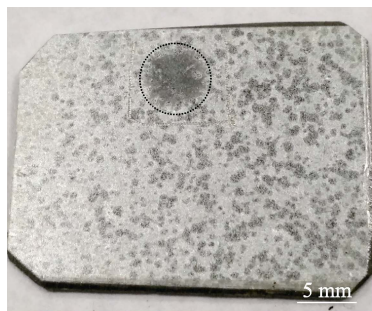
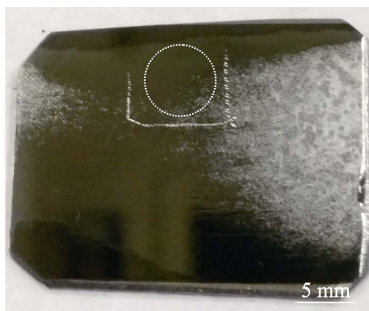
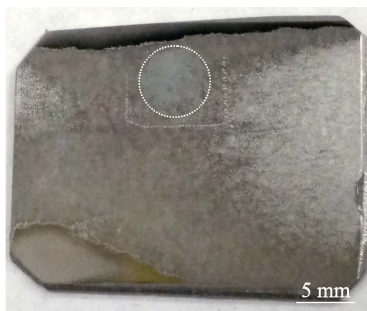
同一个黑点缺陷原始状态、抛光后、金相侵蚀后的宏观形貌对比如图 3 所示,图中圆形标记内为黑点缺陷。在原始状态镀层表面标记的黑点周围,还可见一些弥散分布的、尺寸较小的黑点,判断标记的黑点

图 3 同一个黑点缺陷处理前后宏观形貌对比

缺陷是尺寸较小的黑点较集中的位置。镀层表面经过轻轻磨平并抛光后,原标记位置内的黑点缺陷肉眼不可见,但使用 4% 硝酸酒精侵蚀后,黑点缺陷重新显现,说明缺陷位置可能存在镀层组织差异。同一个黑点缺陷经过多次磨平抛光侵蚀后,黑点缺陷仍可见,判断缺陷位置的镀层组织差异贯穿整个镀层厚度。

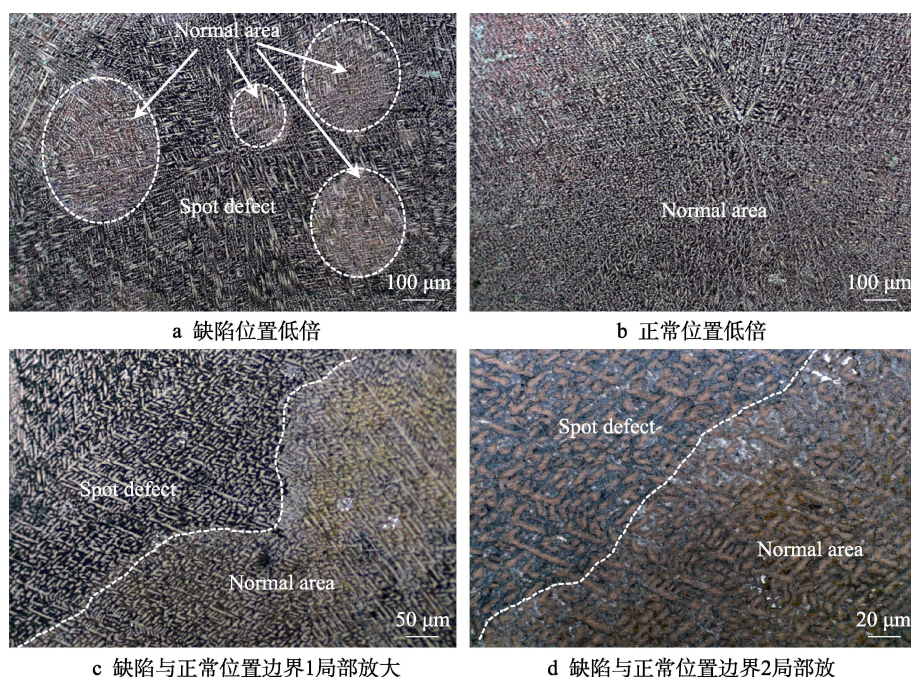
经过抛光侵蚀后的镀层表面光学显微镜照片如图 4 所示,缺陷位置的颜色比正常位置略深。图 4a

所示黑点缺陷内部的圆形斑点颜色与图 4b 所示正常位置较接近。图 4c 和图 4d 局部放大形貌显示,缺陷位置颜色较深主要是因为枝晶间的区域颜色较深,而不同位置 Al 枝晶的尺寸及颜色并无明显差异。

图 4 抛光侵蚀后的镀层表面光学显微镜形貌

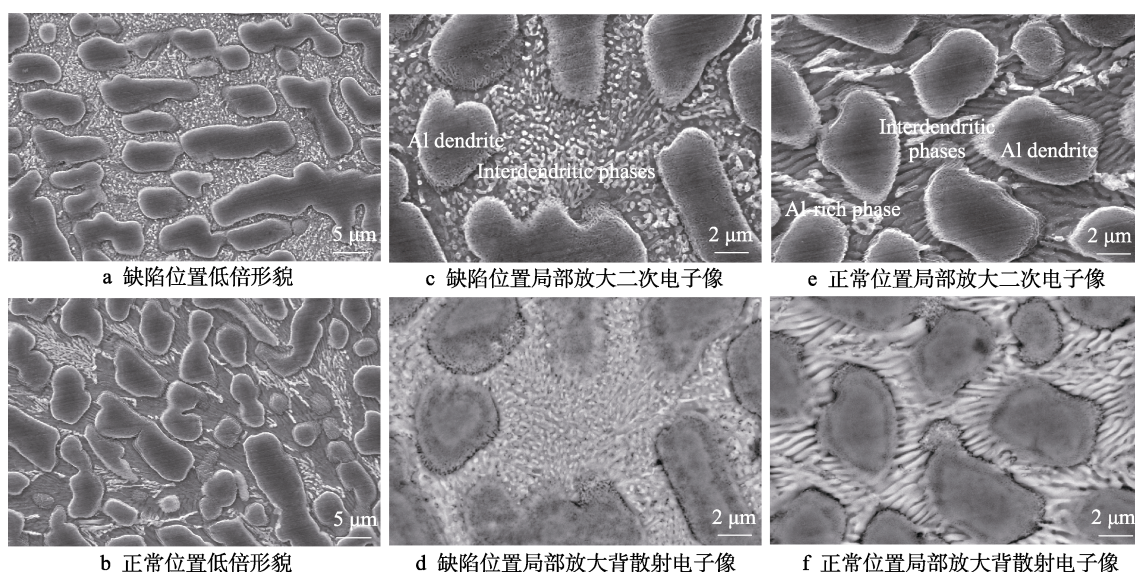
经表面抛光、侵蚀后的镀层表面 SEM 形貌如图 5 所示,不同位置的能谱分析结果如图 6 及表 1 所示。缺陷位置和正常位置的镀层均由 Al 枝晶和枝晶间第二相组成,且 Al 枝晶的形貌、尺寸和成分并无明显

图 5 抛光侵蚀后的镀层表面 SEM 形貌

差异,差别较大的是枝晶间的第二相。缺陷位置枝晶间第二相呈颗粒状,组织比较细小,能谱显示 Al 质量分数为 10%~13%, Mg 质量分数约为 3%,非常接近镀液的原始 Al、Mg 含量。正常位置枝晶间第二相呈层片状,组织较缺陷位置粗大,能谱显示其 Al 质量分数为 3%~5%,明显低于缺陷位置及原始镀液的 Al 含量,而 Mg 质量分数为 4%~5%,高于缺陷位置及原始镀液的 Mg 含量。另外,在图 5b 及图 5e 中,

正常位置枝晶间第二相中还有一些富 Al 相,也呈层片状。

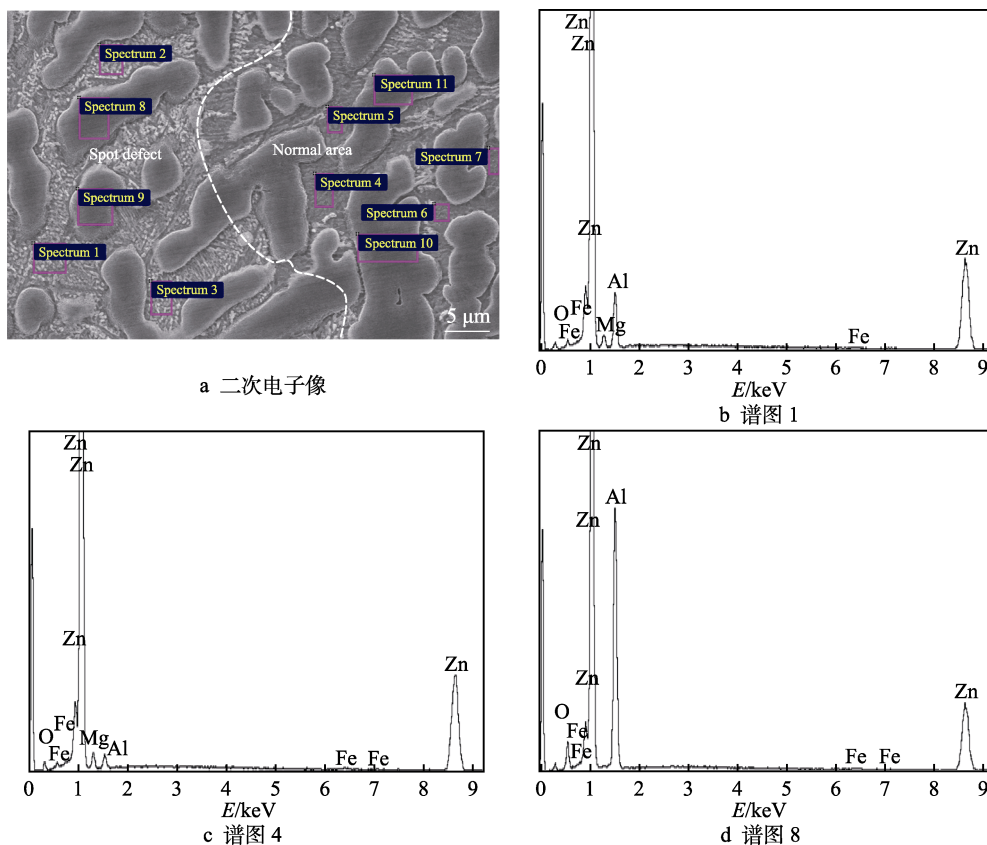
图 6 抛光侵蚀后的镀层能谱分析结果

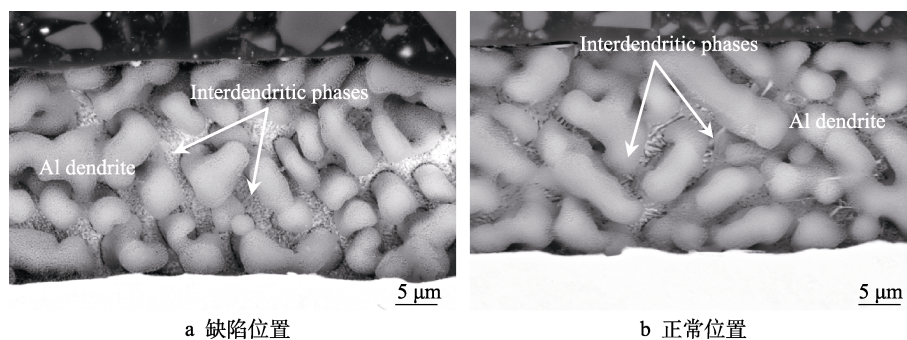
镀层截面 SEM 形貌如图 7 所示,经过硝酸酒精侵蚀后,Al 枝晶及枝晶间第二相区分较明显。截面进一步证实了图 5 观察到的缺陷位置和正常位置枝晶间第二相的差别贯穿整个镀层厚度,而且还观察到初生 Al 枝晶二次枝晶臂尺寸存在差异。在相同面积的视场内,图 7a 所示缺陷位置 Al 枝晶二次枝晶臂的

数量较多, 尺寸较小, 说明缺陷位置和正常位置在 Al 枝晶形成时, 也存在冷却速率的差异。

图 7 镀层截面 SEM 形貌

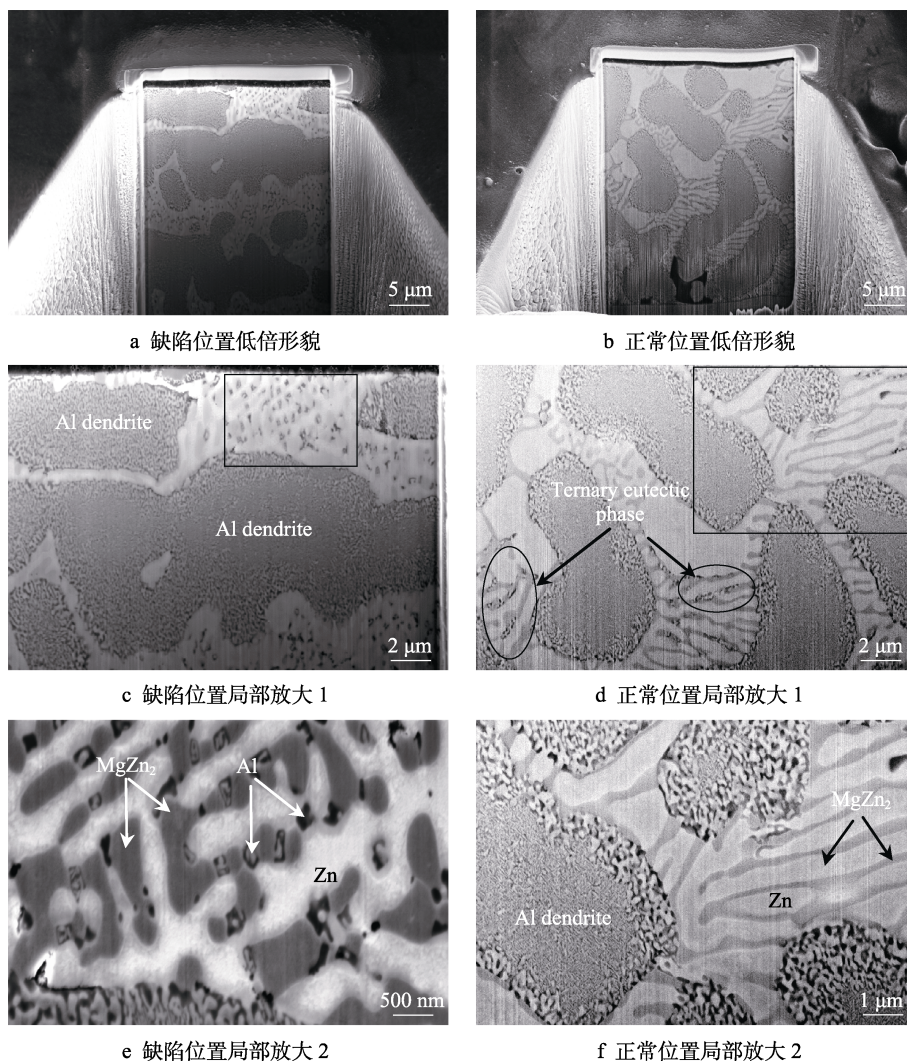
采用 FIB 制备的镀层截面形貌对比如图 8 所示, 局部元素面分布如图 9—10 所示。由图 8a 和图 8b 的低倍形貌可知, 无论是缺陷位置还是正常位置, 在整

个厚度上镀层组织基本是均匀的。放大枝晶间第二相后, 进一步证实了图 5 所示缺陷位置和正常位置镀层枝晶间第二相微观结构的差异。参考 Honda 等<sup>[13]</sup>关于 Zn-11%Al-3%Mg-0.2%Si 镀层凝固组织的研究可知, 图 8e 所示缺陷位置枝晶间第二相由富 Zn 相、

图 8 FIB 制备的镀层截面背散射电子像

Mg-Zn 相及细小的 Al 相组成, 根据其形貌特征可确定为 Zn/Al/MgZn<sub>2</sub> 三元共晶相。图 8f 所示正常位置枝晶间第二相由富 Zn 相和 Mg-Zn 相组成, 根据其形貌可确定为 Zn/MgZn<sub>2</sub> 二元共晶相。在图 8b 和图 8d 局部也可以观察到部分层片状 Al 相, 判断为 Al/MgZn<sub>2</sub> 二元共晶相, 可见正常位置镀层以二元共晶相为主。

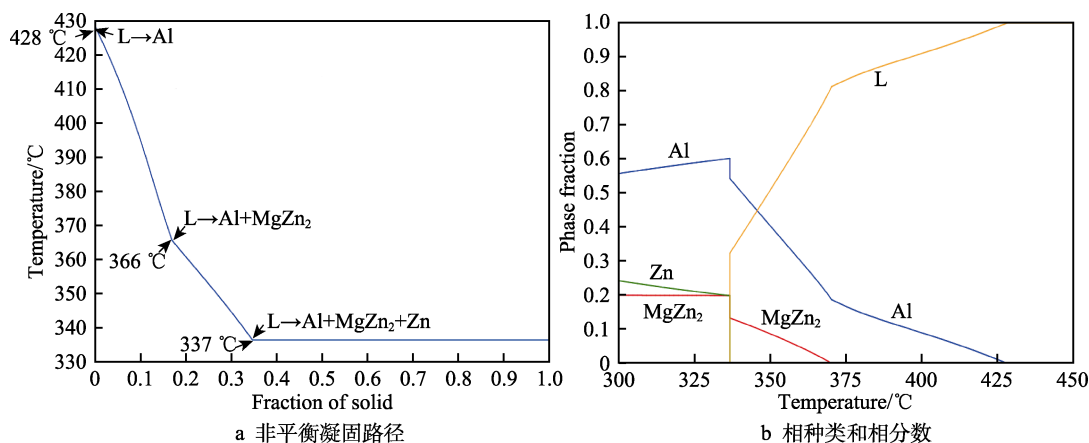
正常位置镀层凝固时经历了如下过程: 当温度降到液相线 ( $t_1=428\text{ }^{\circ}\text{C}$ ) 时, 镀液中首先析出富 Zn 的初生 Al 相, 并以枝晶形式生长; 当温度降至二元共晶反应温度 ( $t_2=366\text{ }^{\circ}\text{C}$ ) 时, 在非平衡态下, 发生  $L \rightarrow \text{Al} + \text{MgZn}_2$  二元共晶反应; 但根据图 8d 和图 8f 所示的镀层截面形貌可知, 还发生了  $L \rightarrow \text{Zn} + \text{MgZn}_2$  二元共晶反应; 当温度继续下降至三元共晶反应温度 ( $t_3=337\text{ }^{\circ}\text{C}$ ) 时, 发生了  $L \rightarrow \text{Zn} + \text{Al} + \text{MgZn}_2$  的三元共晶反应, 当三元共晶反应完成后, 凝固过程结束。上述结果与 Honda 等<sup>[13]</sup>研究的成分为 Zn-11%Al-3%Mg-0.2%Si 的镀层凝固组织有相似之处, 即在镀后冷却过程中, 随着温度逐渐降低, 会陆续发生初生 Al 相析出、二元共晶反应、三元共晶反应及偏析反应等。

图 11 Zn-11Al-3Mg 体系亚稳态相图计算结果

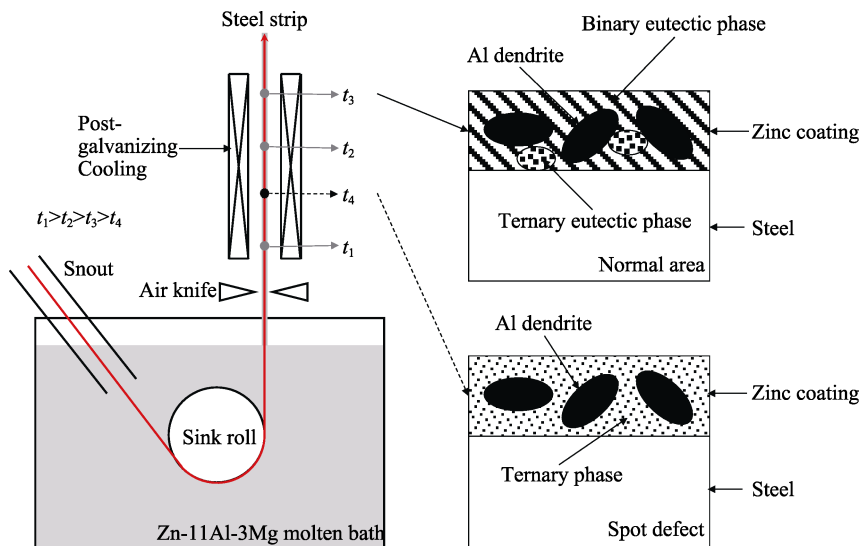
的 Zn、 $\text{MgZn}_2$ 、Al 相均比较细小, 整体成分也较接近镀液的原始成分, 因此判断黑点缺陷位置局部的冷速高于正常位置, 即在镀后冷却  $t_1$  和  $t_2$  之间的某个位置, 局部温度直接降至  $t_4$ , 且  $t_4$  小于共晶反应温度  $t_3$ ,

从而直接形成了细小的三元共晶组织。黑点缺陷形成机理示意图如图 12 所示。引起局部冷速过快的原因包括冷却气体流量的不均匀性, 冷却气体管道内异物或者带钢周围灰尘、水汽等与镀层表面接触。

图 12 热浸镀 Zn-11Al-3Mg 镀层黑点缺陷形成机理示意图  
Fig.12 Schematic diagram of the formation mechanism of dark spot defect on hot-dip galvanized Zn-11Al-3Mg coating

基于以上机理分析结果, 首先对冷却气体管道进行了清洁, 同时对锌锅至顶辊区域内的环境进行了清理, 避免带钢周围的灰尘接触未凝固的镀层产生局部

冷却速度过快。除此之外, 进一步优化了气雾冷却的工艺, 尤其是生产厚规格 (钢板厚度) 和厚镀层带钢时, 避免在带钢未完全凝固前投入气雾冷却。采取上述措施后, 黑点缺陷得到了有效的抑制。
