废气再循环单向阀阀片失效分析及腐蚀防护

(1. 内燃机可靠性国家重点实验室, 山东 潍坊 261061;
2. 潍柴动力股份有限公司, 山东 潍坊 261061)

Failure Analysis and Corrosion Protection of the Exhaust Gas Recirculation Valve

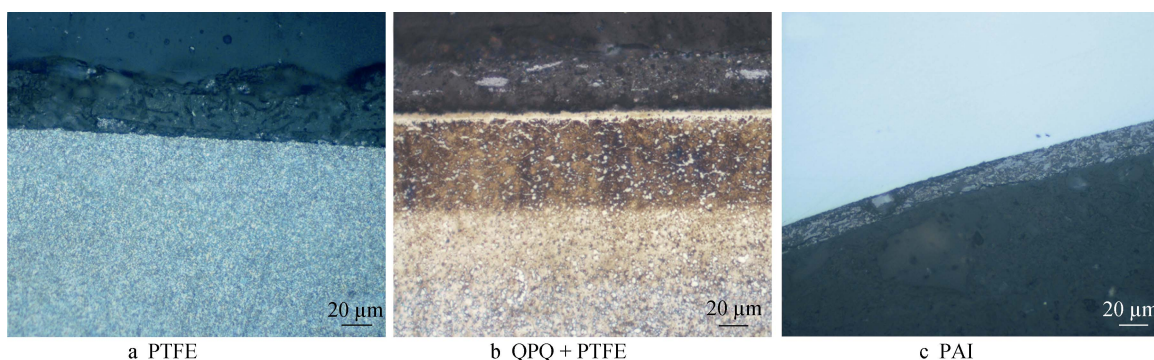
图 5 不同涂层阀片的截面形貌

在 4Cr13Mo 不锈钢基体上制备 3 种不同涂层的样片若干, 包含聚四氟乙烯 (PTFE) 涂层、淬火-抛光-淬火 (QPQ)+PTFE 涂层和聚酰胺酰亚胺涂层, 3 种涂层的截面形貌如图 5 所示。由金相显微镜下的截面形貌可以看出 3 种涂层的厚度相当, 均为 20 μm 左右, 基体组织由回火马氏体组织和球状不溶碳化物组成, QPQ 处理的阀片由表面至心部依次为白亮层、

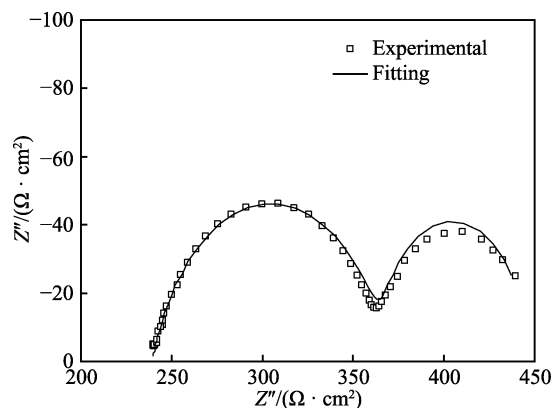
图 6 4Cr13Mo 在模拟冷凝水中的电化学阻抗谱
Fig.6 EIS of the 4Cr13Mo steel in the simulated condensed solution

4Cr13Mo 在模拟冷凝水中的电化学阻抗谱如图 6 所示。由频谱特征可以看出, EIS 表现为双容抗弧特征, 分别代表电极表面电荷转移过程的高频区容抗弧和表示钝化膜溶解/沉积过程的低频容抗弧。

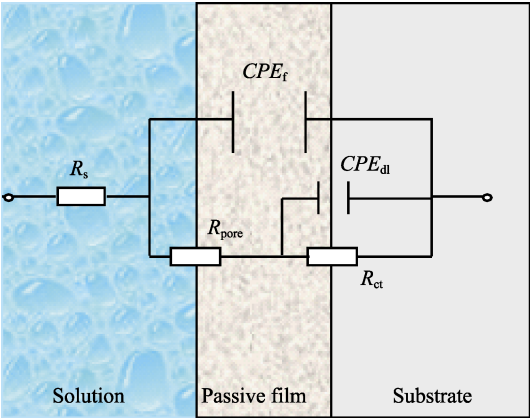
图 7 4Cr13Mo 在模拟冷凝水中 EIS 的等效电路模型
Fig.7 Equivalent circuit of 4Cr13Mo steel in the simulated condensated solution (R_s is solution resistance, CPE_f is passive film capacitance, R_{pore} is passive film resistance, CPE_{dl} is double layer capacitance, R_{ct} is charge-transfer resistance)

采用图 7 所示的等效电路模型对 EIS 进行数据解析, 图 7 中 R_s 表示溶液电阻, R_{pore} 表示钝化膜电阻, R_{ct} 为电荷转移电阻, 解析得到的电化学参数如表 2

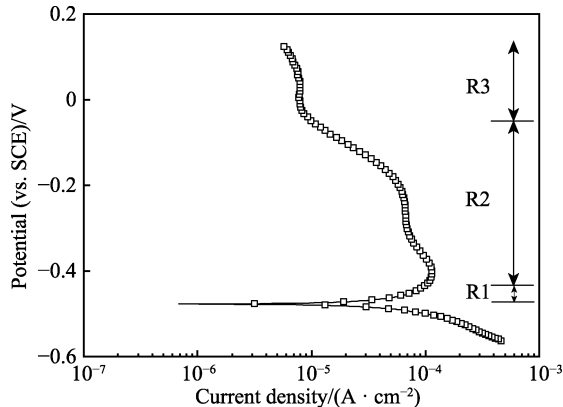
图 8 4Cr13Mo 不锈钢在模拟冷凝水中的动电位极化曲线
Fig.8 Potentio-dynamic polarization curve of the 4Cr13Mo steel in the simulated condensated solution.

图 8 为 4Cr13Mo 不锈钢在模拟冷凝水中的动电位极化曲线。由极化曲线可以看出,在所测量的电位区间内,阴极反应过程为氢离子的活化反应过程控制,阳极分支由活性溶解区(R1)、活化-钝化转变区(R2)和钝化区(R3)组成。由表 2 解析的电化学参数可以看出,由于 Luggin 毛细管引起溶液电阻较大,溶液电阻对极化曲线的影响主要体现为极化曲线的阳极分支在过电位较大的区域发生畸变,阳极分支 Tafel 直线区缩短,为消除溶液电阻的影响,在拟合时对极化曲线进行“溶液电阻补偿”处理。采用 Tafel 直线外推法对动电位极化曲线进行解析^[23],得到其主要动力学参数为:阴极 Tafel 斜率 $b_c=-122 \text{ mV/dec}$,自

腐蚀电位 $E_{\text{corr}}=-0.477 \text{ V}$,自腐蚀电流密度 $J_{\text{corr}}=8.78 \times 10^{-5} \text{ A/cm}^2$ 。由解析得到的动力学参数可以看出,4Cr13Mo 钢在模拟冷凝水中具有较高的溶解速率,而活化-钝化转变区间长,说明钝化膜在测试体系中的稳定性差。

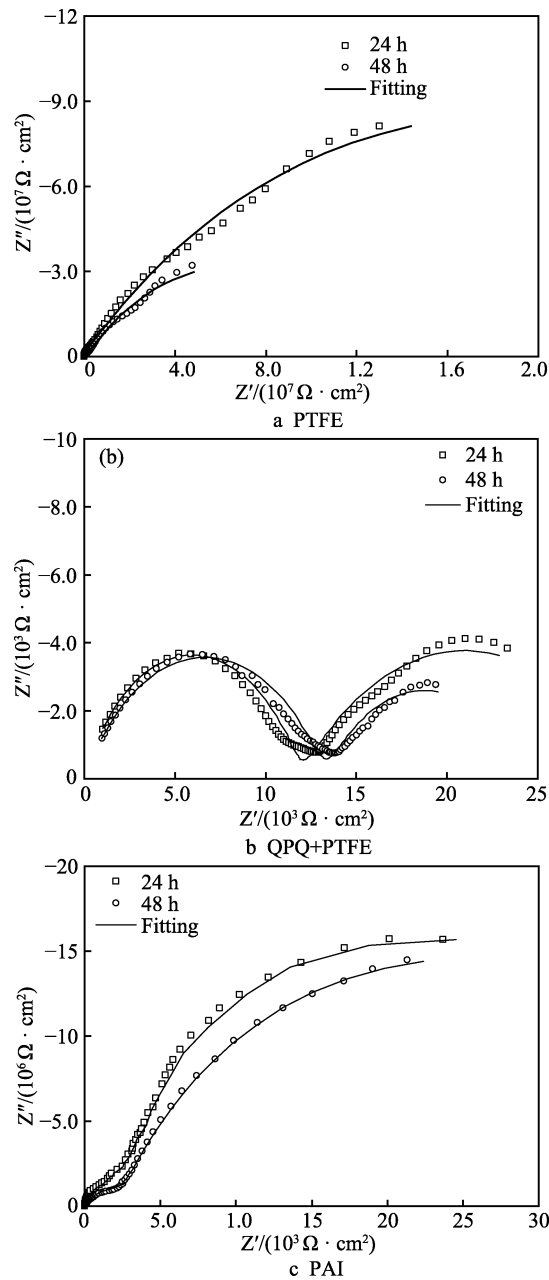
图 9 不同涂层阀片在模拟冷凝水中的电化学阻抗谱
Fig.9 EIS of the valve with different coatings in the simulated condensated solution

图 9 为 3 种表面有涂层的阀片在模拟冷凝水中不同浸泡时间的电化学阻抗谱。在浸泡初期,涂层完整,水溶液通过涂层微孔向内渗透^[24],但未到达涂层/金属界面,此时的涂层能够完全隔离溶液与金属基体的接触,电化学阻抗谱只表现出一个表示涂层性质的单容抗弧^[25-26],涂层的电容性特征明显。图 9 中 3 种涂层阻抗谱均表现为双容抗特征,表明涂层均处于浸泡

中期阶段,随浸泡时间的延长,溶液到达涂层/金属界面,并在界面处发生电化学反应,破坏涂层与金属基体间的结合,电化学阻抗谱具有双容抗弧特征,涂层的电容性特征减弱,电阻性特征增强。

延长,涂层电容 Y_c 逐渐增大而涂层孔隙电阻 $R_{pore, sol}$ 减小,电荷转移电阻减小,这是由于与涂层相比,溶液的电阻小、电容大,随着涂层吸水率的增加, Y_c 增加而 $R_{pore, sol}$ 减小,涂层/金属基体界面腐蚀反应活性位点增多,腐蚀加速。表征 3 种涂层耐蚀性大小的电荷转移电阻表现为: PAI > PTFE >> QPQ+PTFE。

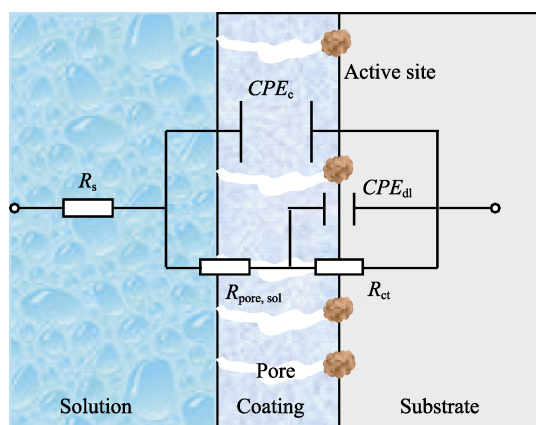
图 10 带涂层阀片 EIS 的等效电路模型
Fig.10 Equivalent circuit of the valve with coatings for fitting EIS data (CPE_c —coating capacitance, $R_{pore, sol}$ —coating resistance.)

采用图 10 所示的等效电路模型对 EIS 进行数据解析,其中 CPE_c 表示涂层电容特性的常相位角元件, $R_{pore, sol}$ 表示涂层孔隙电阻,解析得到的电化学参数列于表 3 中。
