饮用水水质对缺陷涂层腐蚀行为的影响

摘要：目的 研究带缺陷环氧富锌涂层在不同水质的饮用水模拟溶液中的腐蚀机理, 为饮用水输水管内壁涂层的选用提供建议。**方法** 采用电化学阻抗谱(EIS)研究涂层浸泡过程中的电化学行为, 分别采用扫描电子显微镜(SEM)、EDS能谱仪和拉曼光谱对腐蚀产物的形貌和成分进行分析。**结果** 在含 Ca^{2+} 较多的溶液中, 缺陷处形成了致密的水垢, 并在水垢附近形成了双层锈结构; 在含 Ca^{2+} 较少的溶液中, 坊的生长受到限制, 缺陷处布满黄锈, 并且起泡现象严重。**结论** 涂层在硬度较小的溶液中具有更好的抗渗性; 而在硬度较大的溶液中更容易形成粗大而紧密堆积的碳酸钙柱状晶, 覆盖在缺陷处形成水垢, 阻碍涂层的阴极剥离和阴极起泡过程。对于输送软水的饮用水管道, 内壁涂层的防划伤是关键; 对于输送硬水的饮用水管道, 内壁涂层的抗渗能力是关键。

Effects of Drinking Water Hardness on Corrosion Mechanism of Defected Coating

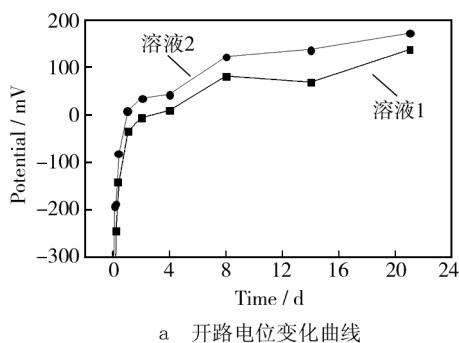
a 开路电位变化曲线

图1 完好涂层试样在两种溶液中的EIS测试结果

Fig. 1 Open circuit potential (a) and impedance module at frequency of 0.01 Hz versus (b) immersing time in solution 1 and 2 for intact coating sample

将完好涂层分别浸泡在两种模拟溶液中,在测试的 21 天内,其开路电位均正移,如图 1a 所示,但在溶液 2 中电位更高,即发生腐蚀的趋势更小。图 1b 的低频阻抗模值变化曲线表明,随着浸泡时间的延长,完好涂层在溶液 2 中的阻抗模值下降后,又小幅回

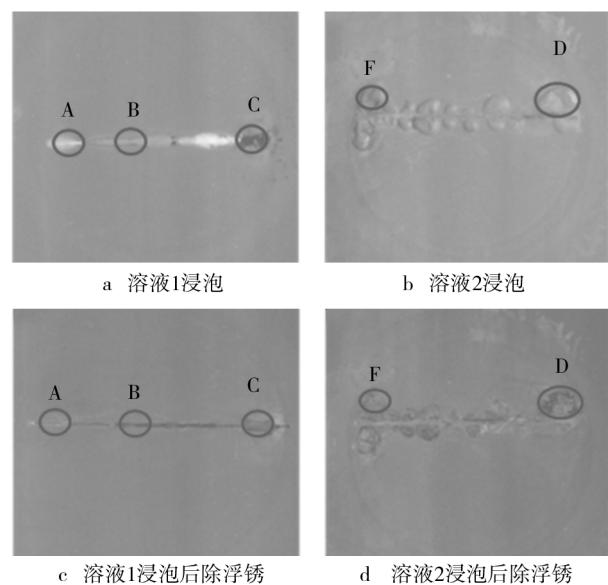
图2 缺陷涂层试样浸泡后的表面宏观形貌

Fig. 2 Surface morphologies of the defected coating after 21-day immersions : a) in solution 1, b) in solution 2, c) rust removal for solution 1, d) rust removal for solution 2

缺陷涂层试样分别在两种模拟溶液中浸泡21天后的表面宏观形貌如图2所示。图2a显示,涂层在溶液1中浸泡后未出现起泡现象,腐蚀产物仅在缺陷处堆积,并未向缺陷两侧的涂层下扩展。图2b显示,浸泡在溶液2中的涂层起泡现象非常严重,将F处拱起的涂层挑破后,可以看到泡下堆积着大量的锈蚀产物,如图2d所示。另外,从腐蚀产物的颜色分析,在两种溶液中的情况也有很大不同。在溶液2中,腐蚀产物为单一的黄锈,用细针轻轻刮去表层黄锈(D处),观察到下层锈蚀产物仍以黄锈为主,只夹杂着很少量的白色物质,并未观察到有黑色锈蚀产物;在溶液1中,产物有白、黄、黑三种颜色,刮去上层物质后,发现B处黄锈下层为黑锈,C处黑锈下基体表面覆盖有少量黄锈,而A处白色物质下为光亮的金属基板,无任何锈蚀迹象。

结合 2.2 小节中的腐蚀产物形貌分析, 可以推测白色物质为钙的化合物, 黄锈和黑锈均为铁的腐蚀产物。根据 Reddy 等人的报道^[11], 缺陷涂层在腐蚀介质中会形成双层锈结构, 外层为疏松的黄色铁锈 FeOOH , 内层为致密的黑色铁锈 Fe_3O_4 。因此可以推断, 黄锈的主要成分为 FeOOH , 黑锈可能为 Fe_3O_4 。为了进一步确定腐蚀产物的具体成分, 对图 2 中 A, B, C, D 四处进行了拉曼光谱分析, 结果见图 5。根据文献^[12], 方解石 (CaCO_3) 在常温下的拉曼光谱如图 6 所示。本实验测得白色腐蚀产物的拉曼光谱含有 $151, 280, 1085 \text{ cm}^{-1}$ 特征峰, 见图 5a, 与 CaCO_3 的拉曼峰 $155, 282, 1087 \text{ cm}^{-1}$ 相一致, 因此判断白色产物为 CaCO_3 。杨晓梅等^[13]列出了 Fe_3O_4 的拉曼特征峰位置, 即 $298, 319, 420, 560, 680, 1322 \text{ cm}^{-1}$, 图 5c 中黑锈的拉曼峰 $322, 1323 \text{ cm}^{-1}$ 与之吻合, 可见黑色铁锈的成分为 Fe_3O_4 。拉曼光谱中的 $383, 476 \text{ cm}^{-1}$ 两个峰代表晶体结构中 $\text{Fe}-\text{O}-\text{Fe}$ 和 $-\text{OH}$ 基团的存在^[14]。Clark 等^[15]给出了黄色铁氢氧化物 $\text{FeO}(\text{OH})_x \cdot \text{H}_2\text{O}$ 的拉曼峰, 即 $244, 299, 384, 412, 476, 543 \text{ cm}^{-1}$, 图 5b 中的 $381, 478 \text{ cm}^{-1}$ 拉曼峰和图 5d 中的 $386, 476 \text{ cm}^{-1}$ 拉曼峰均能与之对应, 说明在两种模拟溶液中浸泡得到的黄色铁锈均为 FeOOH 。

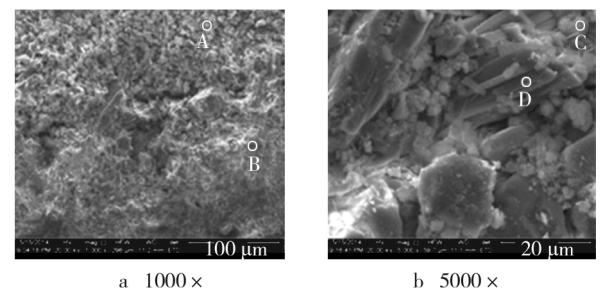
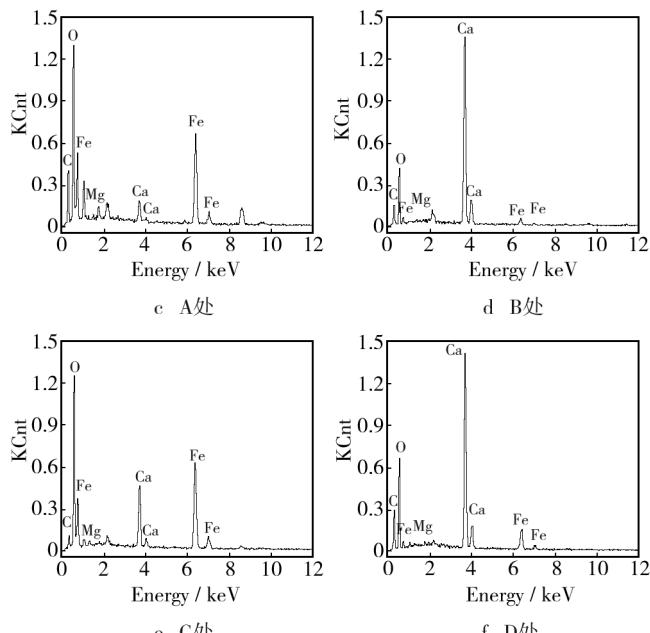
图3 缺陷涂层试样在溶液1中浸泡后的SEM形貌及EDS能谱

Fig. 3 SEM micrograph and EDS energy spectrum of defected coating after 17 days immersion in solution 1

产物的 SEM 形貌及其 EDS 能谱图。从图 3b 可以看出, 溶液 1 中涂层破损处的腐蚀产物形貌主要有两大类: 一类呈较小的球状颗粒, 从能谱(图 3e)分析来看, 球状腐蚀产物中含有大量的 Fe 和 O 元素, 而 Ca 和 Mg 元素的含量较少, 可推测其主要为 Fe 的腐蚀产物; 另一类腐蚀产物为较粗的柱状晶, 且晶柱生长较为充分, 能谱图(图 3f)显示, 柱状晶中以 Ca 元素为主, 几乎不含 Fe 元素, 可见其主要为溶液中的 Ca^{2+} 结晶析出的产物。另外, 从图 3a 的较低倍照片中可以看出, 腐蚀产物堆积较为紧密, 出现了结块现象, 能谱图显示板块处含有大量的 Ca 元素(见图 3d)。由此可以推测, 在腐蚀过程中, 溶液中的 Ca^{2+} 结晶析出形成水垢, 堵塞在疏松的锈蚀孔隙中, 结成致密的板块, 阻挡了溶液的渗透。

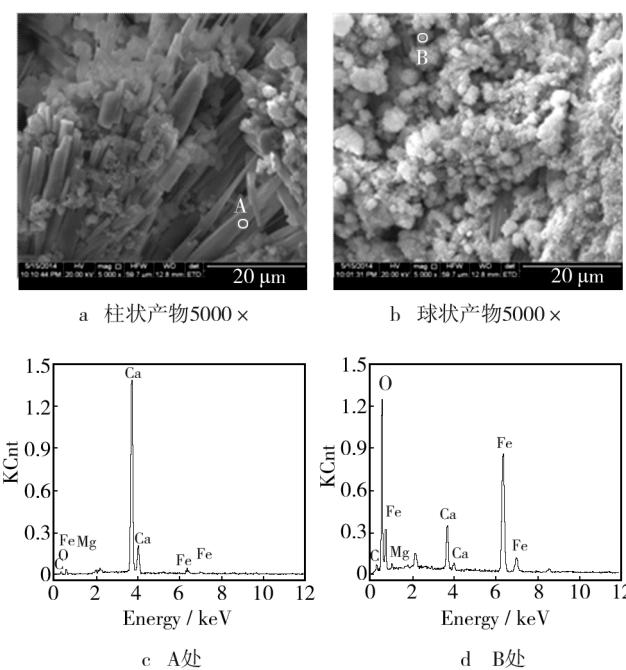
图 4 涂层试样在溶液 2 中浸泡后的 SEM 形貌及 EDS 能谱
Fig. 4 SEM micrograph and EDS energy spectrum of defected coating after 17 days immersion in solution 2

图 4 为试样在溶液 2 中浸泡 17 天后缺陷处腐蚀产物的 SEM 形貌及其 EDS 能谱图。图 4 中仍然可以观察到球状和柱状晶两种形态的腐蚀产物, 其中球状产物含 Fe 元素较多, 而柱状产物含有大量的 Ca 元素, 这与在溶液 1 中的情况相似。不同的是, 图 4a 显示在溶液 2 中的腐蚀产物堆积较为疏松, 含 Ca 柱状晶细而短, 并且间距较大。含 Ca 柱状晶生长受限导致缺陷处在溶液 2 中没有形成致密的水垢, 溶液中的离子较易从缺陷处向两边涂层下扩散, 这与之前的宏观形貌分析结果吻合。

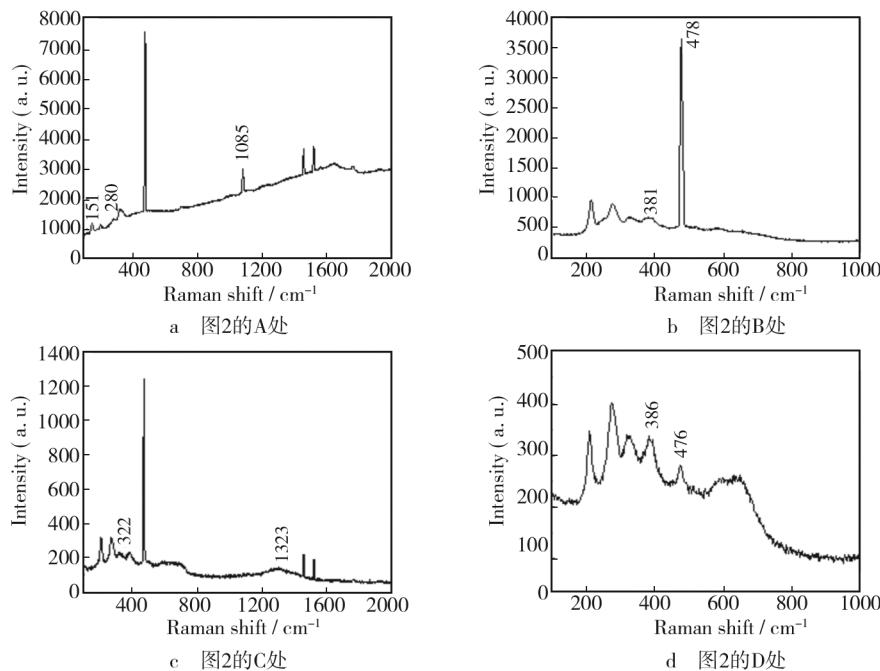
图5 图2中各处不同腐蚀产物的拉曼光谱测试结果

Fig. 5 Raman spectra of different corrosion products shown in Fig. 2

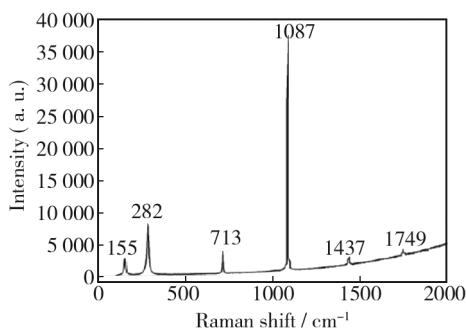
图6 方解石在常温常压下的拉曼光谱^[12]Fig. 6 Raman spectra of calcite at ambient temperature and pressure^[12]
