磨损对 U71Mn 材料表面高温氧化行为的影响

摘要: 目的 研究 U71Mn 钢轨材料磨损后的高温氧化行为, 探讨高温和磨损对钢轨表面损伤的影响机制。
方法 用磨损试验机对材料进行磨损试验, 将磨损不同程度的材料在加热炉中进行氧化实验, 用带能谱的扫描电镜对材料界面进行表征, 用 XRD 对氧化物相进行分析, 研究磨损对 U71Mn 钢轨材料表面高温氧化性能的影响。**结果** 磨损量随载荷增加而变大。在 800、900 °C 保温 5 h 后, 未磨损材料比磨损材料质量增加明显。这是因为磨损材料表面产生划痕裂纹, 空气中的氧在裂纹尖端快速吸附, 扩散到裂纹尖端的基体中, 生成氧化物, 降低了裂纹前沿原子键结合能, 造成材料表面大面积脱落。在 900 °C, 未磨损 U71Mn 材料高温加热后, 表面氧化膜主要为 Fe₂O₃, 500 N 磨损材料高温氧化膜主要成分为 FeO 和 Fe₃O₄ 相, 1000 N 磨损材料氧化膜主要成分为 Fe₂O₃ 和 Fe₃O₄ 相。**结论** 未磨损 U71Mn 钢轨材料的耐高温氧化性能明显优于磨损材料。磨损会加速材料高温损伤, 且具有一定的方向性。轮轨摩擦划痕严重影响高温氧化膜的相结构和附着力, 从而影响钢轨的使用寿命。

Effect of Wear on Oxidation Behavior of U71Mn at High Temperature

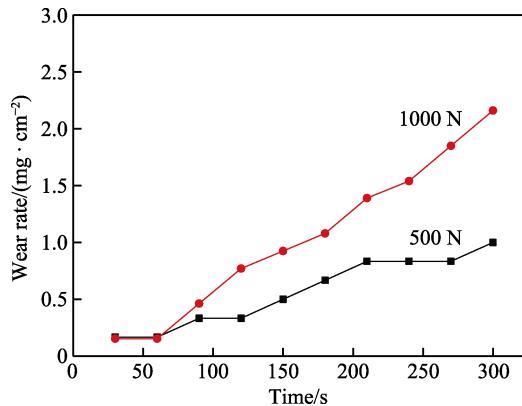
如图1所示，500 N条件下，磨损率随着磨损次

图1 U71Mn材料在500、1000 N下的磨损率

Fig.1 Schematic diagram of wear rate of U71Mn material at 500 N and 1000 N

数的增加而增大, 呈现阶梯式增长, 增长速度比较缓慢。1000 N 条件下, 随着磨损次数的增加, 磨损率基本处于直线式增长, 相较于 500 N, 其增长速度明显加快。随着磨损载荷的增加, 材料磨损量快速变大, 说明随着高铁不断向重载方向演变, 对钢轨本身的损害加重。

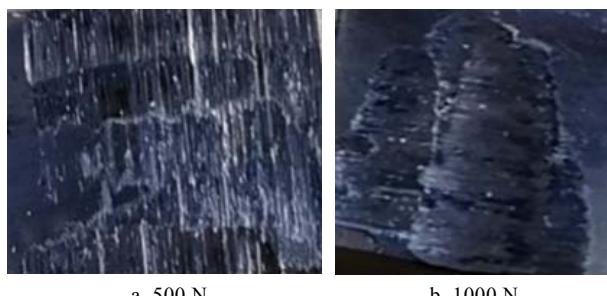
材料在 500 N 磨损后, 宏观表面出现大量划痕, 划痕明显且均匀分布, 如图 2a 所示。1000 N 磨损材料的宏观表面出现凹陷, 划痕加深, 且呈不均匀分布, 相对集中在中部区域, 如图 2b 所示。磨损实验施加的载荷越大, 划痕形成的速度越快, 凹陷越深, 越容

图 2 U71Mn 材料在 500 N 和 1000 N 下磨损后的宏观形貌
Fig.2 Macroscopic morphology of U71Mn material after 500 N and 1000 N wear

易形成划痕集中区。这种不均匀分布的划痕不利于钢轨材料的长期使用。

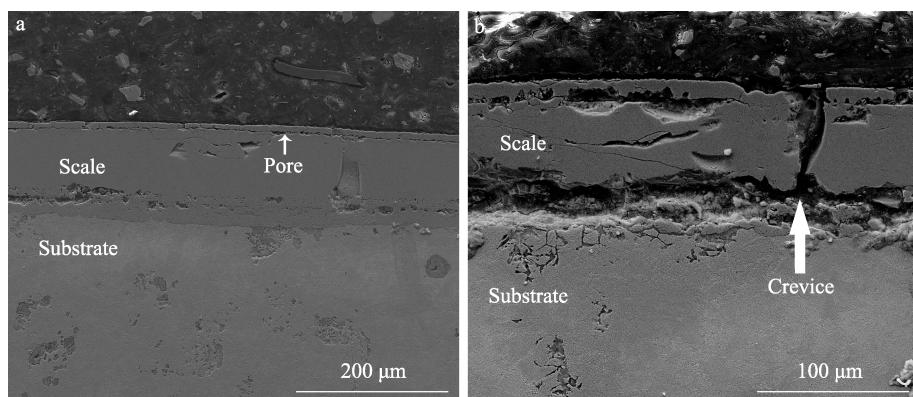
未磨损 U71Mn 材料在 800 °C 下的氧化截面形貌如图 3 所示。未磨损材料在 800 °C 下保温 5 h 后, 部分氧化层基本完整, 且最外层和次外层之间有明显的裂缝, 在氧化膜和基体之间出现了大量的空洞, 尤其是在氧化膜与基体界面附近, 有一条近似连续的空洞, 如图 3a 所示。这是因为, 在氧化初期, 铁和氧

充分接触, 反应速度较快, 氧化膜不致密, 从而在初期形成的氧化膜上形成了一条近似连续的空洞。随着时间的推移, 材料表面逐渐被氧化膜覆盖, 限制了铁向外扩散, 氧化膜形成速度逐渐减缓。在扫描电镜下能够看到, 中间层的氧化膜相对比较致密。同时, 未磨损 U71Mn 材料在 800 °C 氧化后, 也会出现如图 3b

图 3 未磨损 U71Mn 材料在 800 °C 氧化后的截面形貌
Fig.3 Cross-sectional morphology of unworn U71Mn at 800 °C

所示的形貌，即部分区域氧化层和基体之间出现很宽的裂缝，裂缝处物质碎裂掉落，且氧化层出现贯穿式裂缝。这是因为在部分区域，最外层不稳定的氧化层发生掉块，氧化膜与基体界面处空洞不断扩散连续，造成最外层掉块区域逐渐和界面空洞连接贯穿，从而造成这部分区域结构不稳定。若实验时间延长，这部分区域氧化膜发生脱落，会造成钢轨材料的加速失效。

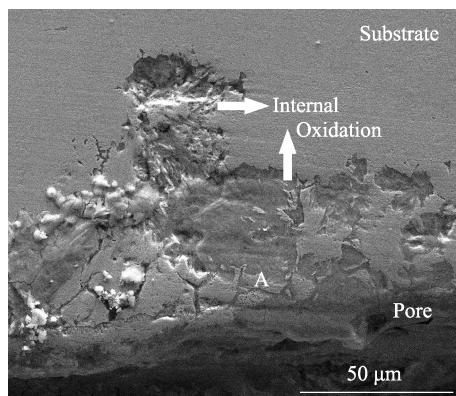
1000 N 磨损 U71Mn 试样在 800 °C 下的氧化截面形貌如图 4 所示。由图 4 可知，1000 N 磨损试样在 800 °C 下保温 5 h，截面上几乎观察不到氧化层。造成这种现象的原因可能是，材料磨损造成了深划痕裂纹，空气中的氧在裂纹尖端发生吸附和吸收，氧原子扩散到基体中，使这一区域变脆。氧降低了裂纹前沿的原子键结合能，吸附氧使得裂纹表面能下降，生成氧化物^[27]。因此，氧在裂纹区聚集，降低了晶界金属晶体的原子间结合力，造成表面脱落。在图 4 中观察到氧化向材料基体内扩展的现象，即内氧化现象，扩展深度约为 800 μm，且内氧化也有明显的脱落现象，氧化腐蚀程度较重。内氧化是因为材料磨损造成的大批宏观划痕成为氧向内扩散的最优通道。内氧化使得材料的内应力急剧增加，自由能升高，内氧化区域通过氧化物的塑性变形、开裂和剥离，降低自由能，并释放内应力。用 EDS 分析图 4 中的 A 区域，其成分为 15.96Fe-0.5Mn-0.1P-0.16Si-52.69O-30.59C，表明 A 区域主要为 Fe₂O₃。这通过 XRD 分析也得到了证实，如图 5 所示。此外，从图 4 还可以观察到，氧化层脱落后，在材料表面呈现出疏松的空洞状。

图 4 1000 N 磨损 U71Mn 材料在 800 °C 氧化后的截面形貌
Fig.4 Cross-sectional morphology of U71Mn material worn with 1000 N at 800 °C

800 °C 氧化后，试样表面的 XRD 分析如图 5 所示。由图 5 可知，未磨损及 500、1000 N 磨损试样表面的 XRD 峰基本一致，其氧化膜成分主要为 Fe₂O₃ 相。这个结果与对图 4 中的 A 区域进行 EDS 分析的结果相吻合。磨损试样的 Fe₂O₃ 峰值明显高于未磨损试样，说明磨损试样表面膜的 Fe₂O₃ 含量显著增加。

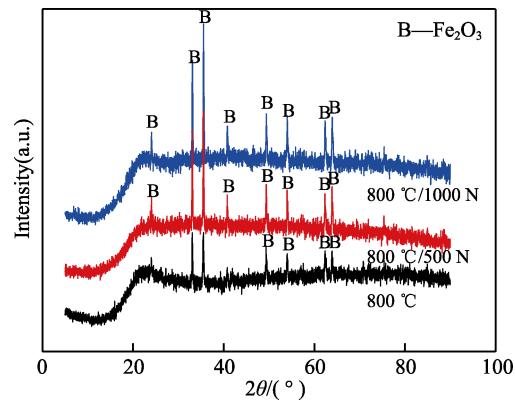
1000 N 磨损试样的 XRD 峰相对较宽，表明其氧化产物晶粒尺寸较大。这是因为温度升高，材料表面粒子活性增强所致。

图 5 未磨损及磨损 U71Mn 试样在 800 °C 氧化后的 XRD 分析
Fig.5 XRD patterns of U71Mn samples at 800 °C

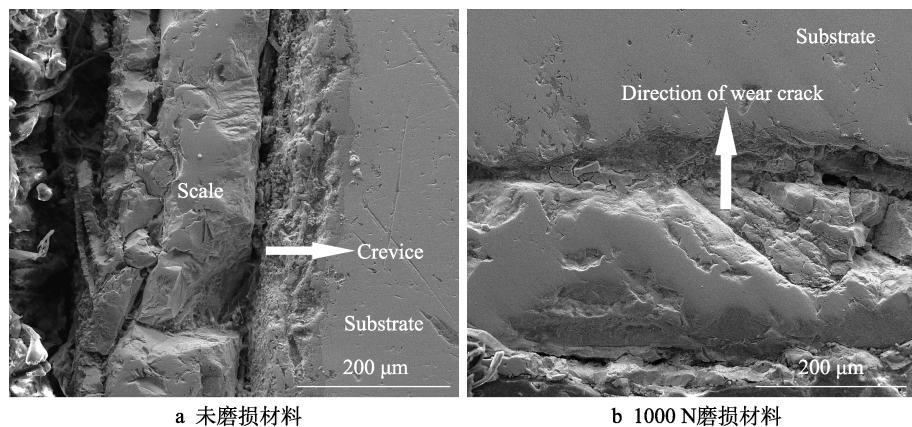
未磨损、1000 N 磨损 U71Mn 试样在 900 °C 保温 5 h 的截面形貌如图 6 所示。由图 6 可知，未磨损试样在 900 °C 下保温 5 h 后，基本存在多层氧化物，层与层之间的结合力较差，氧化层和基体之间出现很宽的裂缝。说明材料在这种条件下的氧化层不牢靠，延长时间后，极易造成氧化膜的脱落。1000 N 磨损试样在 900 °C 保温 5 h 后，氧化层几乎全部脱落，氧化向基体内扩散程度加重，内部很宽的破坏层出现与基体剥离的趋势。这个结果与氧化增重的结果相吻合，即未磨损材料的氧化增重远高于磨损材料。1000 N 磨损试样在 900 °C 保温 5 h 后，氧化物快速生长，呈现厚且脆的特征，同时磨损裂纹降低了氧化物与基体之间的结合力。因此，试样从高温加热炉内取出时，观察到大部分表面氧化物破碎并脱落在坩埚底部。在制备截面试样的过程中，试样的镶嵌、打磨、抛光，进一步使得表面氧化物几乎全部脱落。从图 6 可以观察到，向材料内部延伸的破坏层呈现出一定的方向性，与材料预磨损裂纹划痕方向基本一致。这说明磨损会加速材料高温损伤，且具有一定的方向性。

图 6 未磨损及 1000 N 磨损 U71Mn 试样在 900 °C 保温 5 h 的截面形貌

Fig.6 Cross-sectional morphology of U71Mn material at 900 °C: a) unabraded material; b) 1000 N wear material

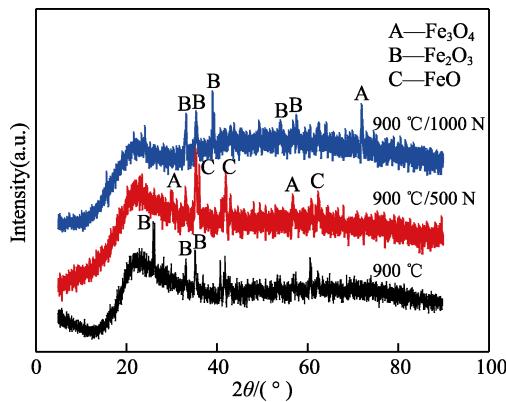
900 °C 氧化试样表面的 XRD 分析结果如图 7 所示。由 XRD 分析可知，在 900 °C 氧化后，未磨损试样表面氧化膜的主要成分为 Fe₂O₃，500 N 磨损试样为 Fe₃O₄ 和 FeO。这主要是因为磨损划痕造成材料表面宏观缺陷，成为氧化活性区，氧化活性强，在很短的时间内形成了稳定的 Fe₃O₄，但氧化膜在划痕上生长速度快、不稳定，使部分 Fe₃O₄ 发生脱落，内部裸露的基体部分再次发生氧化，生成 FeO。因此，在 XRD 图谱上，存在明显的 Fe₃O₄ 和 FeO 的衍射峰。1000 N 磨损试样表面氧化膜的主要成分为 Fe₃O₄ 和 Fe₂O₃，这是因为后期形成的 FeO 和氧发生反应，从而形成相对较稳定的 Fe₂O₃。

图 7 未磨损和磨损 U71Mn 试样在 900 °C 氧化后的 XRD 分析

Fig.7 XRD patterns of U71Mn samples at 900 °C
